Name Of Dam: FALLS MILLS DAM

Inventory Number: VA 18503

PHASE I INSPECTION REPORT

NATIONAL DAM SAFETY PROGRAM

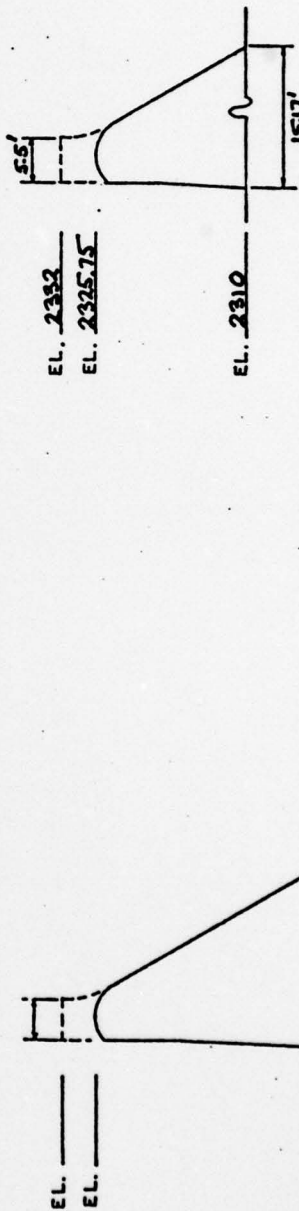
PARTIAL SECTION

The stability calculations performed for the masonry dam indicate the factor of safety for sliding is less than that recommended in Reference 7 of Appendix V and the resultant of overturning forces does not lie within the middle third of the dam as recommended in Section 4.4.4.4 of Reference 7 of Appendix V. These recommendations are for concrete gravity dams, however, it is our opinion that similar guidelines should apply to masonry dams.

NOTES: 50% UPLIFT USED FOR ANALYSIS
FOR SLIDING ANALYSIS $\phi = 37^\circ$
 $S = 2.0$ KSF

7.2.2 A study should be made within 6 months to determine the properties of the fill embankment and its foundation soils, as well as the soft shale, the strength parameters of the critical masonry joint, and methods of providing an adequate factor of safety against sliding and overturning. The results of such a study should be implemented soon after the study. It is suggested that the urgency would be determined during the
